# Nondestructive Evaluation (NDE) Techniques Assessment for Graphite/Epoxy (Gr/Ep) Composite Overwrapped Pressure Vessels

30 October 1998

E. C. JOHNSON and J. P. NOKES  
Mechanics and Materials Technology Center  
Technology Operations

SPACE AND MISSILE SYSTEMS CENTER  
AIR FORCE MATERIEL COMMAND  
2430 E. El Segundo Boulevard  
Los Angeles Air Force Base, CA 90245

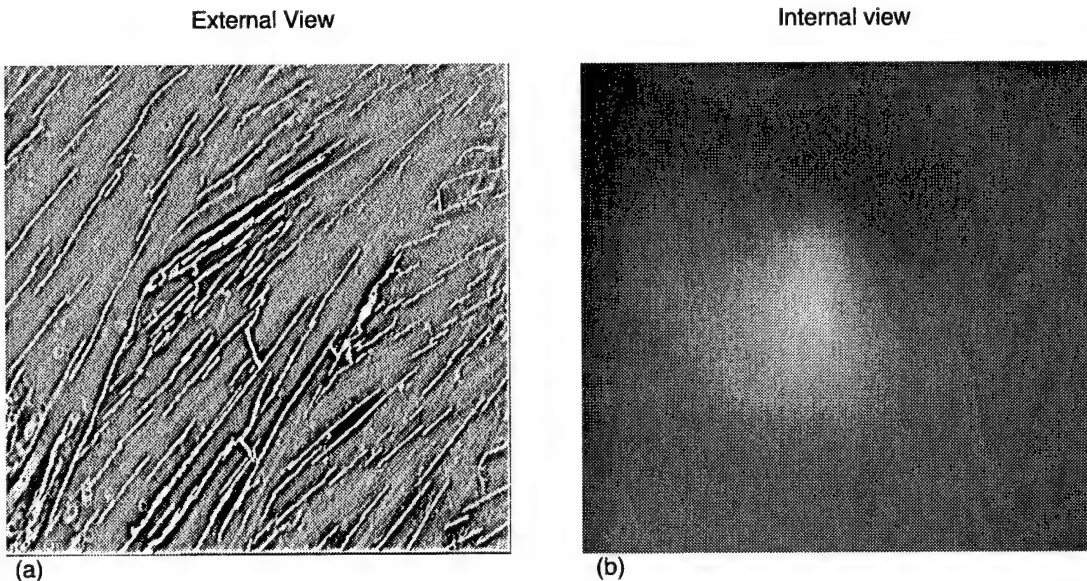
As can be noted from Figure 4a, the outside Gr/Ep surface of the COPV exhibited little, if any, indication of the impact. However, Figure 4b reveals that on the inside liner surface a small dent is very apparent. One can surmise, therefore, that the impact damage at this energy level evolves in the manner depicted in Figure 5; the composite overwrap flexes into the metallic liner to accommodate the impact and then returns to its pre-impact position. The liner, on the other hand, is left dented and locally unbonded from the overwrap. It thus should be strongly noted that a visual inspection of the exterior of the COPV will not serve to detect this type of damage. It should also be noted that if the impact has weakened the composite (broken fibers etc.), there is no obvious visual sign. The presence of the dent in the liner is critical for obtaining satisfactory results for a number of the impact damage detection techniques presented in the balance of this report. This is an important observation.

Figure 4. Visual indications of a 35-J impact damage site on spherical vessel. For the external view, dye penetrant was used to enhance the image.

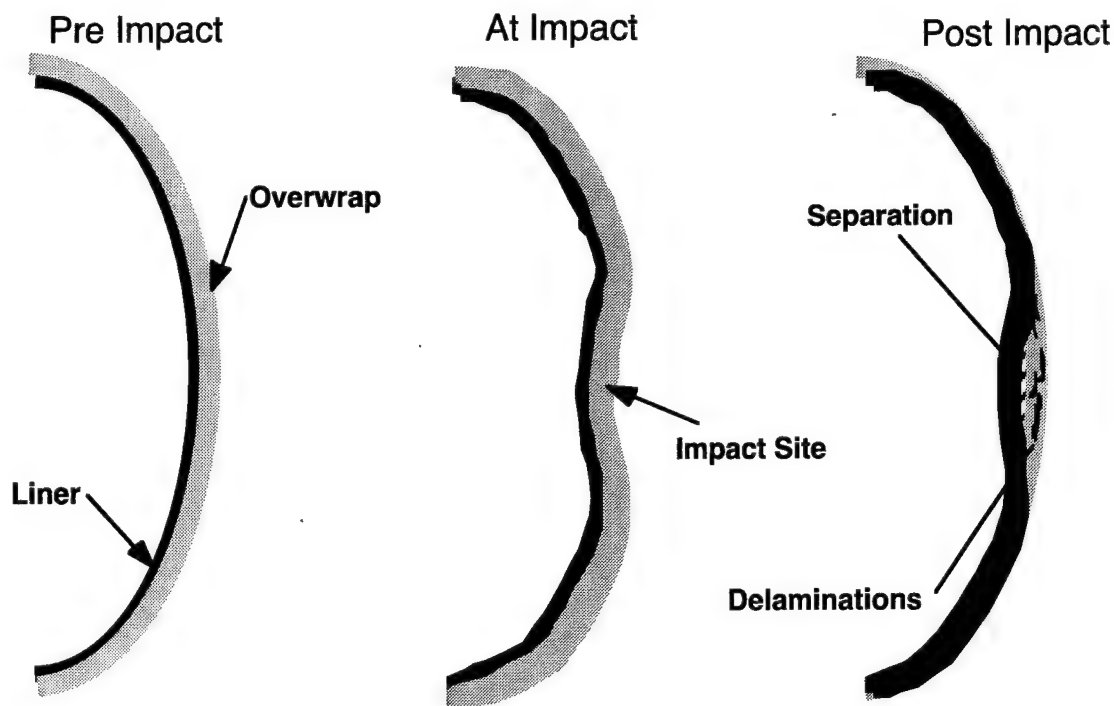
Figure 5. Cross-sectional view of the impact damage event.

It was also noted during this study that, in some instances, repressurization of an impacted COPV caused the dent to disappear. In other words, for some inspection techniques, the effects of an impact can be erased by pressurizing the bottle!

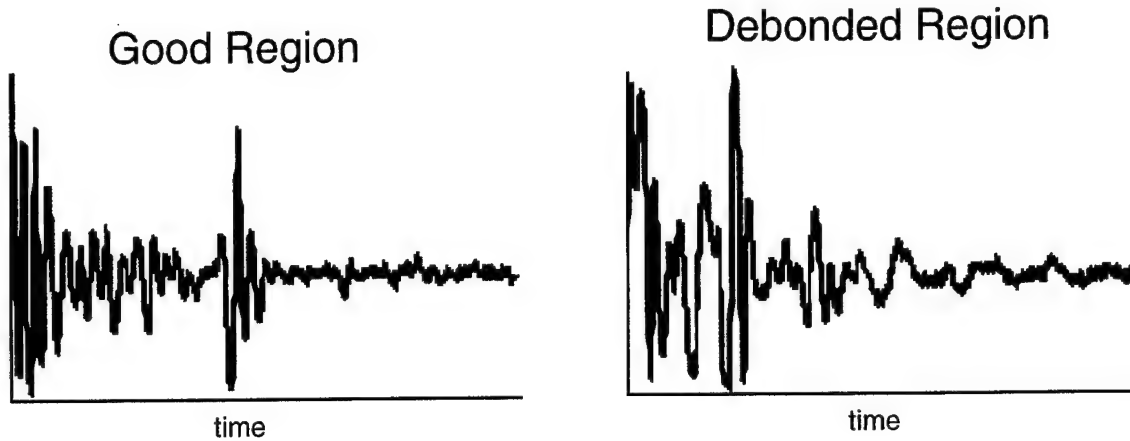
As one might expect, the type of damage described in Figure 5 can be detected using a handheld pulse-echo ultrasonic probe on the outside surface of the COPV. In the region of impact, the ultrasonic pulse returns early because the sound cannot bridge the gap to the dented liner. Damage within the composite results in a decrease in signal amplitude, which can also be detected in some circumstances. A comparison of a typical waveform recorded on an impact site and on an adjacent nominal site is presented in Figure 6.

Figure 6. Pulse echo A-scans from a good and debonded region of an impacted COPV. The measurements were made using a 10-MHz transducer and Ultragel II™ couplant. Note the strong (early) response from the backside of the overwrap in the debonded region.

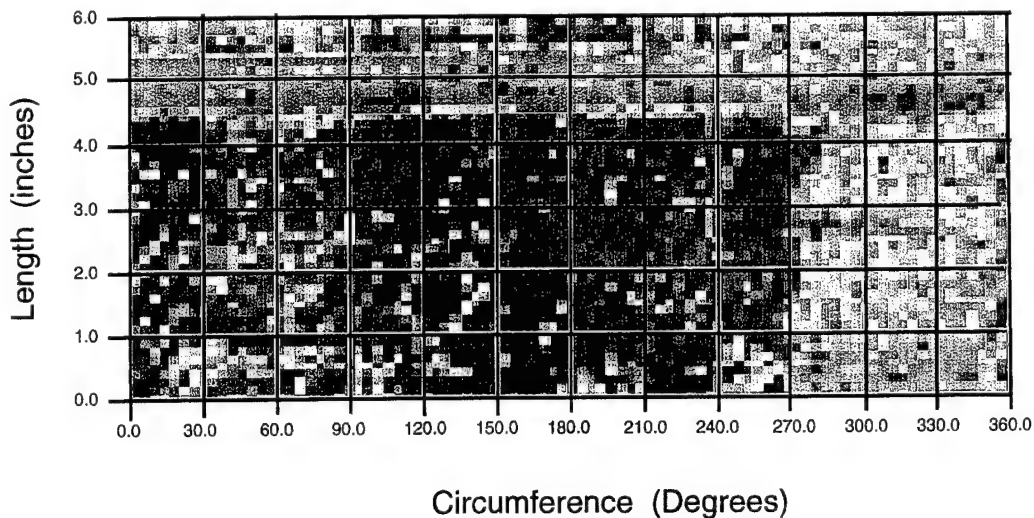
To eliminate variances associated with the hand coupling and positioning of transducers, the impacted COPVs were inspected using both a through-transmission and a pulse-echo ultrasonic technique. In both instances, the COPVs were immersed in and filled with water. For the through-transmission technique, a sound pulse generated by one transducer was received by a second after passing completely through the COPV. For the pulse-echo technique, a reflection rod was inserted into the center of the COPV. In both instances, the amplitude of the 5-MHz pulse was recorded as a function of position after passing through the wall(s) of the COPV. The data revealed that ultrasound can be used to detect non-visible impact damage in COPVs. A C-scan representation of a 10 cm x 23 cm COPV after a 10-J impact is presented in Figure 7. Though the impact left no visible indication on the surface of the COPV, the impact site is clearly visible in the central section of the C-scan image.

Figure 7. C-scan image of a 10 cm x 23 cm COPV after a 10-J impact. The impact site gives rise to an obvious, somewhat circular indication centered at about (125°, 1.5 in). The rectangular indication on the right was due to a label affixed to the bottle. The stripe along the top of the scan was due to the curved edge of the bottle.

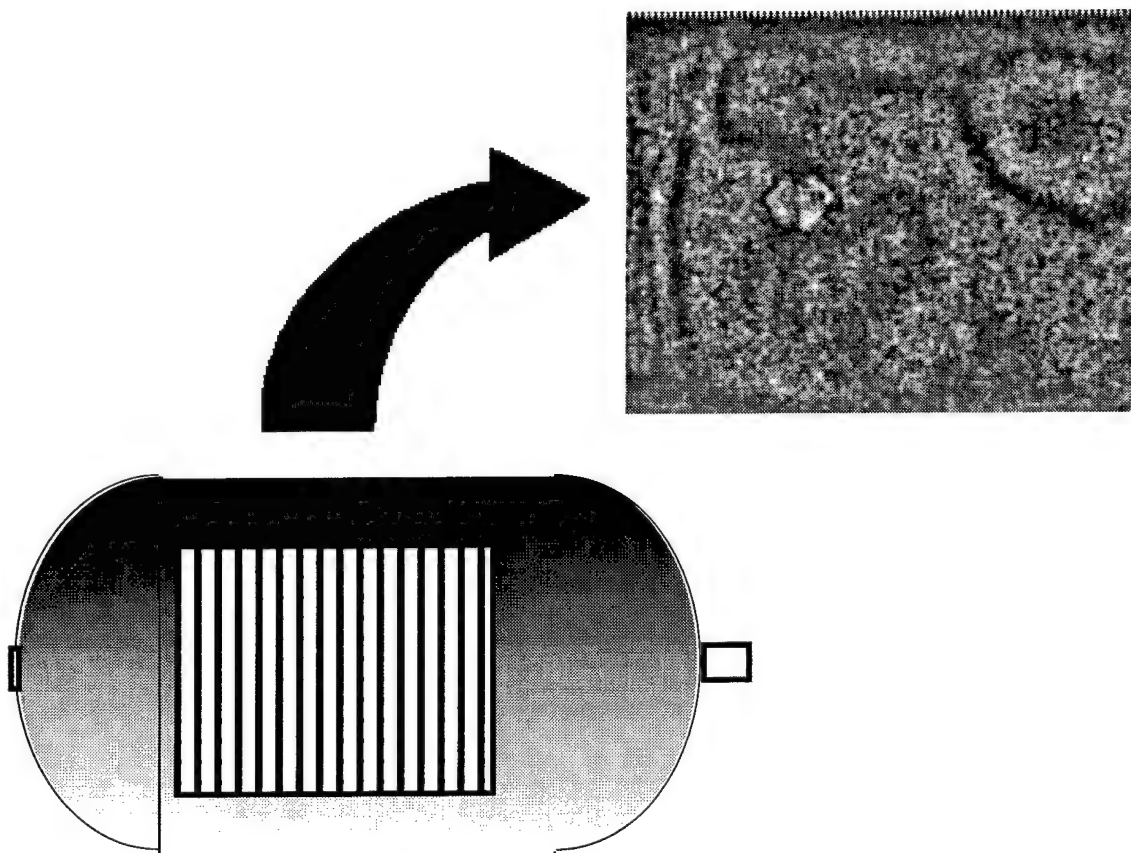
The shearographic technique was found to be particularly effective for detecting impacts in the spherical COPV because of the relatively uniform stress field, as shown in Figures 9a and 9b. The fringes presented in Figure 9a represent the nominal deformations of a spherical COPV under a 40-psi

Figure 8. Shearographic image of 35-J, 25-mm tup impacted cylindrical COPV.

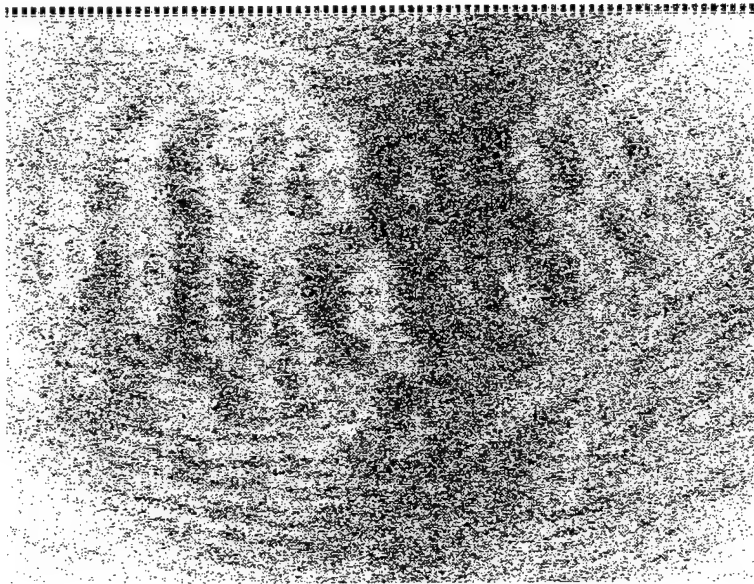
Figure 9a. Initial shearographic image of the spherical COPV using a 40-psi pressure differential.

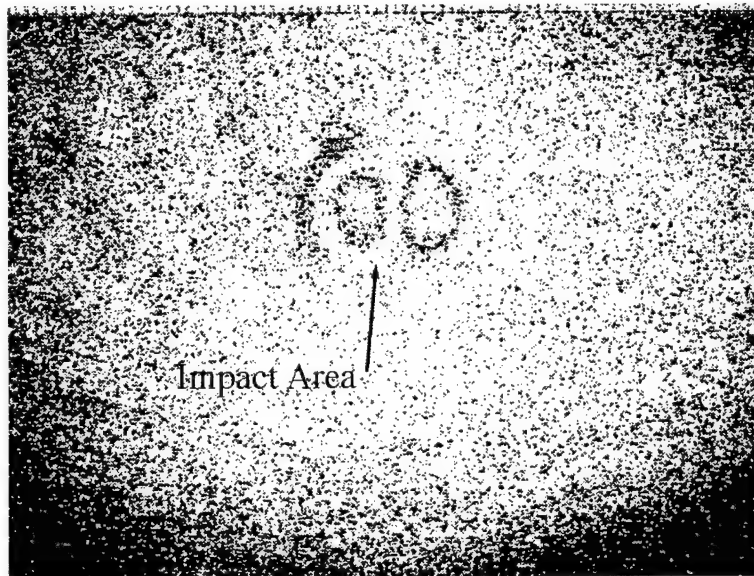
Figure 9b. Post-impact shearographic image of the spherical COPV following a 20-J impact with a 25-mm diameter tup. A 40-psi pressure differential was employed to create the image.

charge. These fringes can be contrasted with the fringes in Figure 9b that clearly indicate the location of a 20-J impact where a 25-mm tup was employed. It should be noted that shearography is a dynamic process in that one can see the indications grow in as the load is applied. This has the effect of making the indications considerably more apparent than is evident from the still images presented. A serious drawback to the use of shearography in this application is the need for a matte surface to

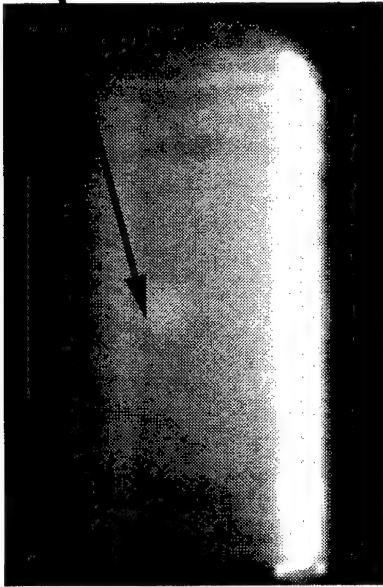
**13 J impact using a 25mm tup**

**Figure 10.** Comparison of thermographic indications on a 10 X 23 cm COPV following distinct 13-J and 20-J impacts.

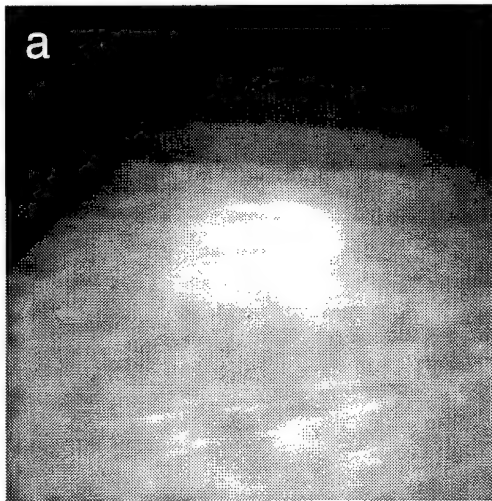
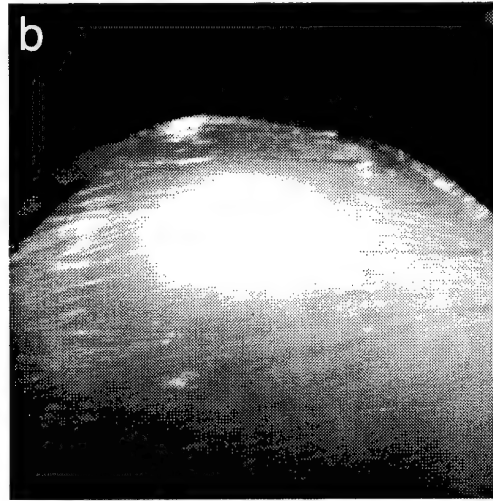
The successful application of thermographic techniques can be affected by the structure of the vessel. It was noted that impacts of less than 45 J gave rise to clear thermographic indications for the spherical vessel included in this study (Figure 11). It might also be noted that similar tests were conducted on several spherical vessels not included in this report, and that 50-J impact sites were not detectable. These vessels had slightly thicker overwraps and/or liners.

**Figure 11.** Thermographic image of a 45-J impact site on the spherical COPV. These images were obtained using an Amber Radiance 1 IR camera (3–5  $\mu\text{m}$ ). The image labeled (a) was acquired ~1 s after the surface was flashed with a high-intensity flash lamp. The image labeled (b) was acquired ~5 s after the surface was warmed with a quartz heat lamp.

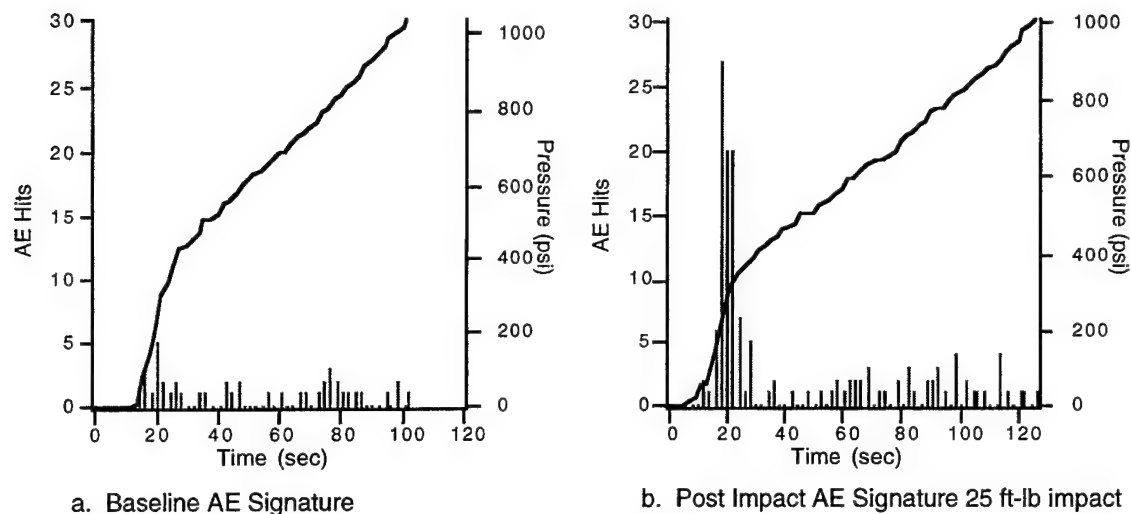
For this investigation, an array of six AE sensors were used to record the acoustic activity of a vessel during pressurization. These transducers were coupled to the COPV with an ultrasonic couplant. COPVs exhibit the Kaiser Effect,<sup>12</sup> which implies that once a structure has experienced a stress level, no new AE will occur again until that stress level has been exceeded, unless, of course, the structure has been damaged before being repressurized. To detect impact damage, the COPVs were subjected to an initial AE screening, and then pressurized again after being subjected to an impact. Changes in the acoustic activity were noted with the COPVs exhibiting significantly more AE events after impacts that exceeded a particular energy threshold. The energy threshold required for AE monitoring to detect an impact varied significantly between vessel types, ranging from 10 J for the small cylindrical COPV to over 20 J for the larger cylindrical vessel. Figure 13 demonstrates the change in AE activity that occurred after a 35-J impact on the 10 x 23 cm cylindrical COPV. In Figure 13a, little AE activity is noted since no damage to the vessel occurred between the original manufacturer's proof pressurization and the AE screening test. Figure 13b reveals a significant increase in AE—clearly indicating a change in the COPV structure as a result of the impact. AE monitoring, however, does not provide a quantitative means for ascertaining the severity of the impact damage. Instead, AE methods appear to offer excellent potential as an impact screening technique. The AE system employed in this study was fairly rudimentary, allowing only for the capture and analysis of several parameters that characterize the acoustic emissions. Emerging technologies that permit a modal analysis of the captured waveforms offer potential for significant improvements in the impact screening process.

Figure 13. Acoustic emission data for for the 10 X 23 cm cylindrical COPV (a) before and (b) after a 35-J impact.
